PTSG dismantles glassworks chimney

[Premier Technical Services Group Ltd \(PTSG\)](#) has completed the systematic dismantling of a 71-metre refractory lined steel [chimney](#) stack for a Yorkshire glassworks.

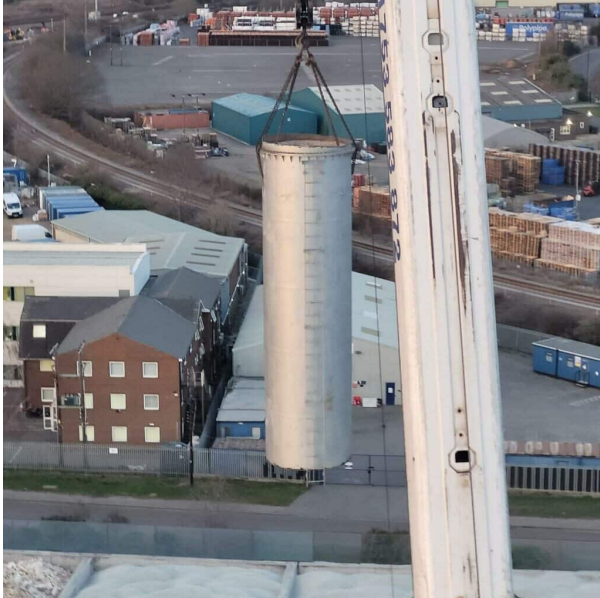
Precision planning needed to be put in place by the team from [PTSG Building Access Specialists Ltd](#) as the entire site was live and under full production. To separate each chimney section into manageable lift sections, the internal refractory lining had to be removed around the internal circumference.

The Group's rope access engineers descended the internal of chimney and systematically removed the lining around each separation point of each chimney section. Using a two-crane configuration, the chimney was burnt around the circumference of the shell by our steeplejacks within a man basket attached to a crane.

The second crane that was attached to the chimney section lifted the load to ground level onto awaiting trucks for disposal. The dismantling process was repeated until the entire chimney was removed from site.
