[PTSG delivers structural strengthening at glassworks](#)

[Premier Technical Services Group Ltd \(PTSG\)](#) has delivered series of remedial works at a glassworks in Scotland following a structural inspection. This was achieved through the use of rope access and steeplejack techniques.

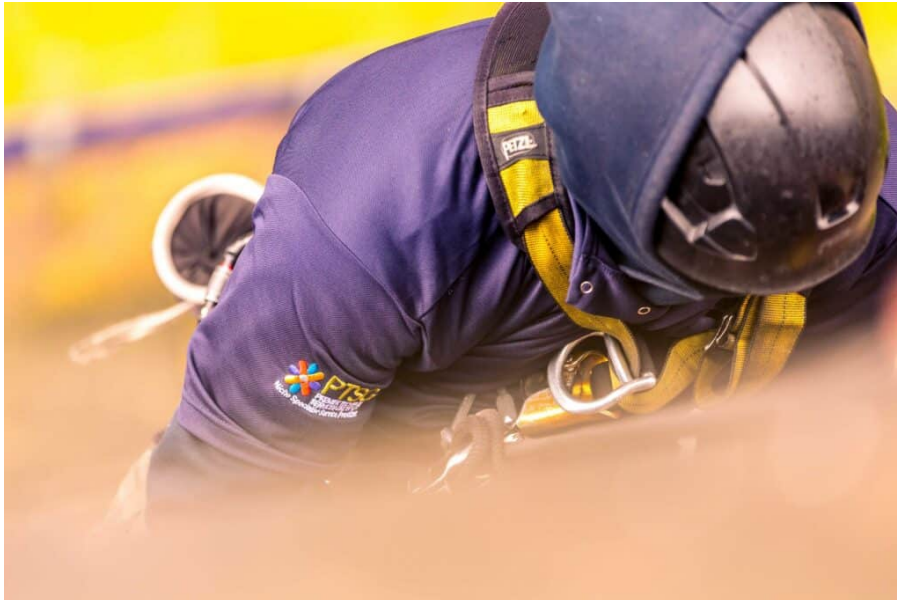
The Scotland glassworks inspection revealed some serious issues with the 40-metre sand silos. It was revealed that holes had developed through the steel. This problem required immediate over-plating to stop the product fragmenting – as well as to strengthen the silo.

Employing a combination of rope access and steeplejack techniques, engineers from [PTSG Building Access Specialists Ltd](#) rolled steel plates to the circumference of the silo, where they welded the weak areas to effect a repair. This will allow the silo to continue to be used safely for the foreseeable future, subject to periodic inspections. The photograph shows PTSG's rope access coded welder enjoying his work.
